# EXAMINATIONS FOR THE DETERMINATION OF LOAD-CARRYING CAPACITY OF THE BRIDGE OVER THE SEBES-KÖRÖS AT VÉSZTŐ

GY. SZABÓ

Department of Steel Structures  
Technical University, H-1521 Budapest

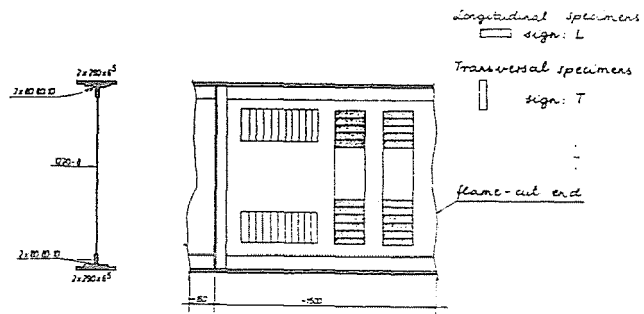
Fig. 1.

Owing to the fact that the flanges were corroded to a very great extent, the tests were performed, first of all, on the samples cut out of the web. The arrangement of cuts is illustrated in *Fig. 1*.

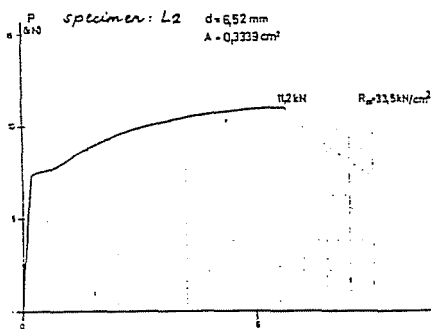
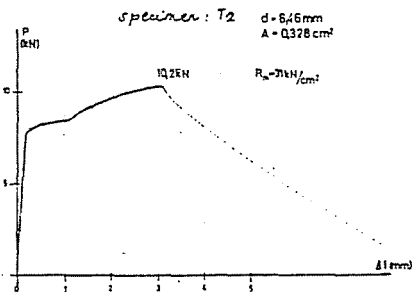
Fig. 4a.

The registration can be seen in *Fig. 4*, while the results are shown in *Table 2*. The values recorded with the use of two types of specimen and the machine shows a satisfying agreement between the data obtained.

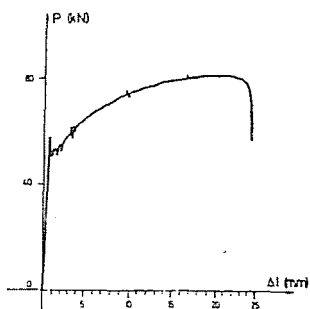
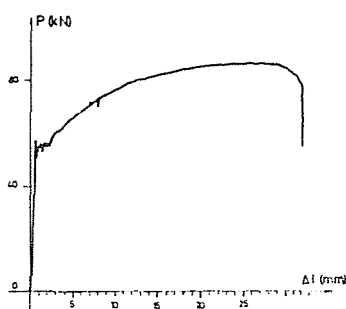
Fig. 5a.

After the completion of fatigue test, flat specimens were processed cut out from the stringer and then the most important characteristics were determined (see *Fig. 5*). The values measured on the two specimens were yielded as follows:

$$R_y = 229 \div 227 \text{ N/mm}^2,$$

$$R_m = 324 \div 344 \text{ N/mm}^2,$$

$$\delta_{5\%} = 17.5 \div 19.5.$$

The yield-point was slightly lower than the values measured on the web of the flood-plain bridge, however the other results were in fact identical.

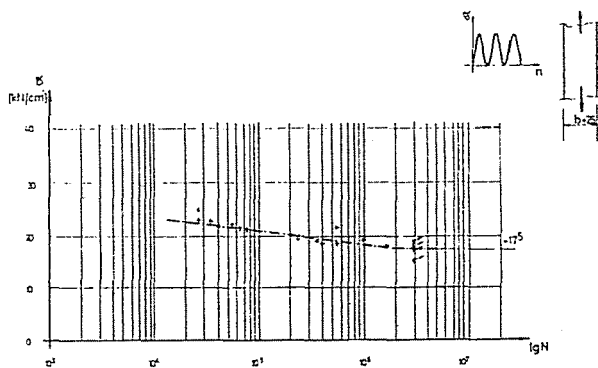
Fig. 6. Fatigue results of flat specimens

The results of the tests are shown in *Figs. 6, 7, 8 and 9*. In addition to the numerical results obtained, the following conclusions can be inferred from the tests:

1. There is no considerable difference between the results obtained with the specimens of longitudinal- and transverse directions.
2. The previous fatigue has no detectable effect on the cycle-number required for failure. The same can be claimed for the specimens which did not suffer failure on the first stress-level chosen under the influence of cycle- number  $3 \cdot 10^6$ .
3. Somewhat greater standard deviation is yielded in comparison to the steel materials used nowadays.

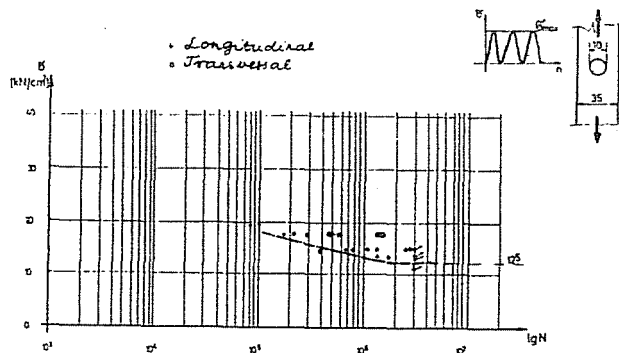
Fig. 7. Fatigue results of bored specimens

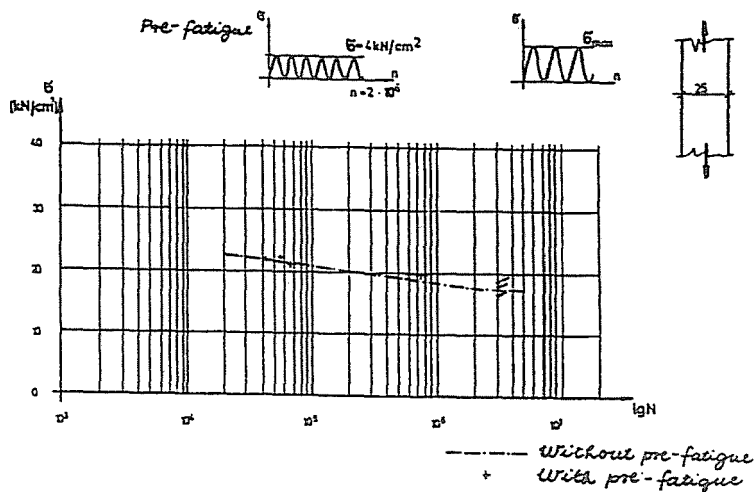
Fig. 8. Fatigue results of specimens subject to previous fatigue

Nine flat-shaped specimens were subject to previous fatigue process on  $\sigma = 40 \text{ N/mm}^2$ , then they were subject to the test mentioned above.

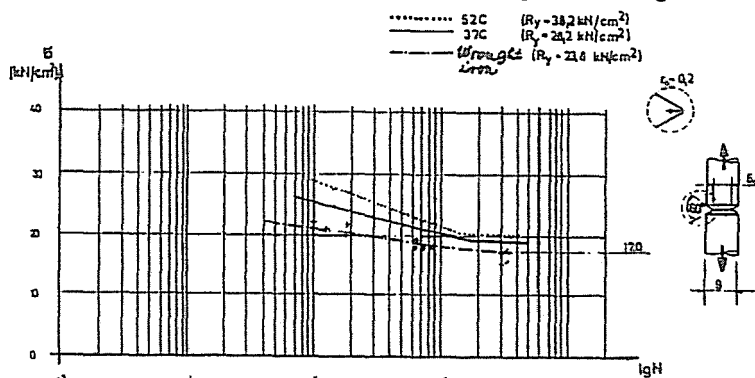
Fig. 9. Fatigue results of notched specimens with circular cross section

For the purpose of a more accurate comparison with the materials used nowadays, the results obtained with the notched specimens of a circular cross-section can serve, as shown in *Fig. 9* since the identical circumstances of the tests can be created technically with these specimens.

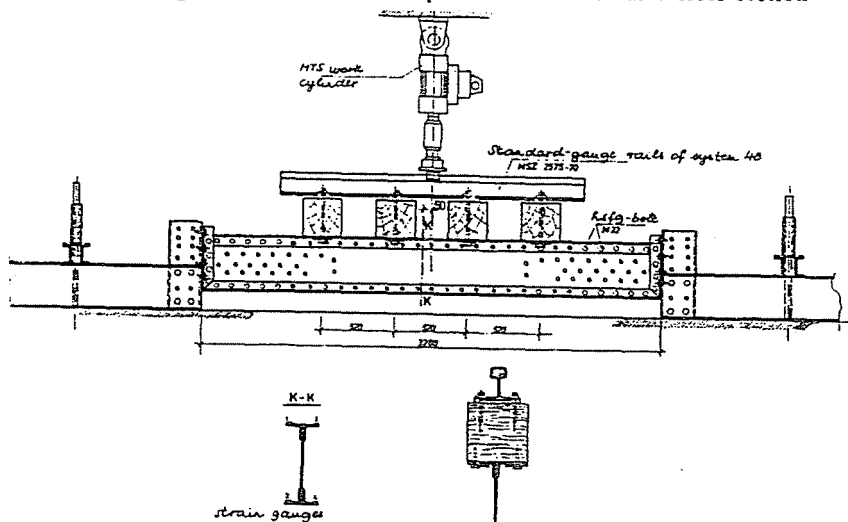
Fig. 10.

According to the original scheme of mounting, pieces of the sleepers, and the normal-gauge rails of type '48' were mounted on the stringer. The fatigue-load was applied by a work-cylinder positioned in the middle of the stringer. The layout can be seen in *Fig. 10*.

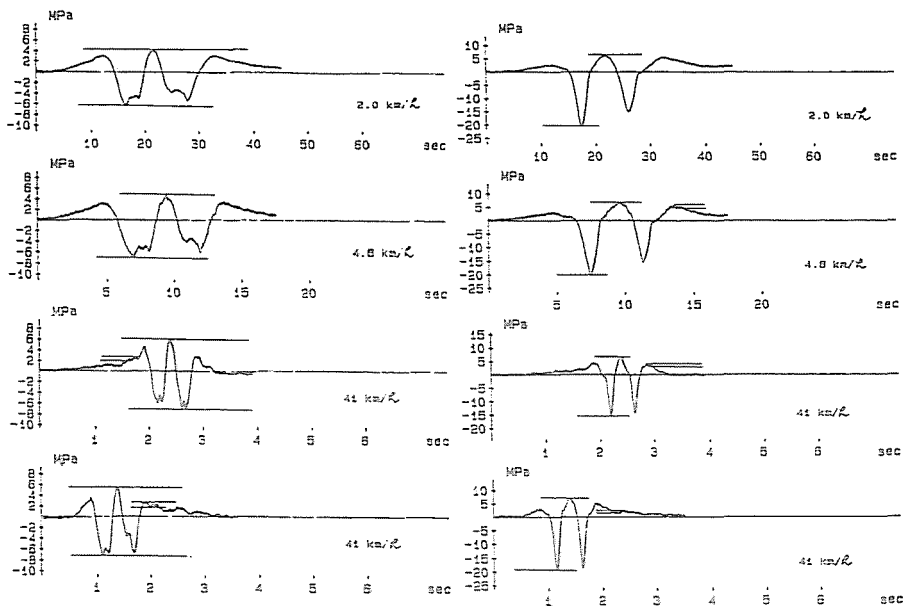
VG.11 Stringer gauge N<sup>2</sup>1 Load: A 124VG.12 Stringer gauge N<sup>2</sup>2 Load: A 124

Number gauge 1			Type of load: A 124 (VQ.11)			
Stresses			MPa			
			Dynamic factor			
	maximum	minimum	delta	max/statmax	min/statmin	delta/absmax
Stat	4.6	-6.4	—	—	—	—
Din1	4.6	-6.6	—	(1.00)	1.03	—
Din2	5.5	-6.9	0.6	(1.20)	1.08	1.05
Din3	5.3	-7.2	0.9	(1.15)	1.13	1.07

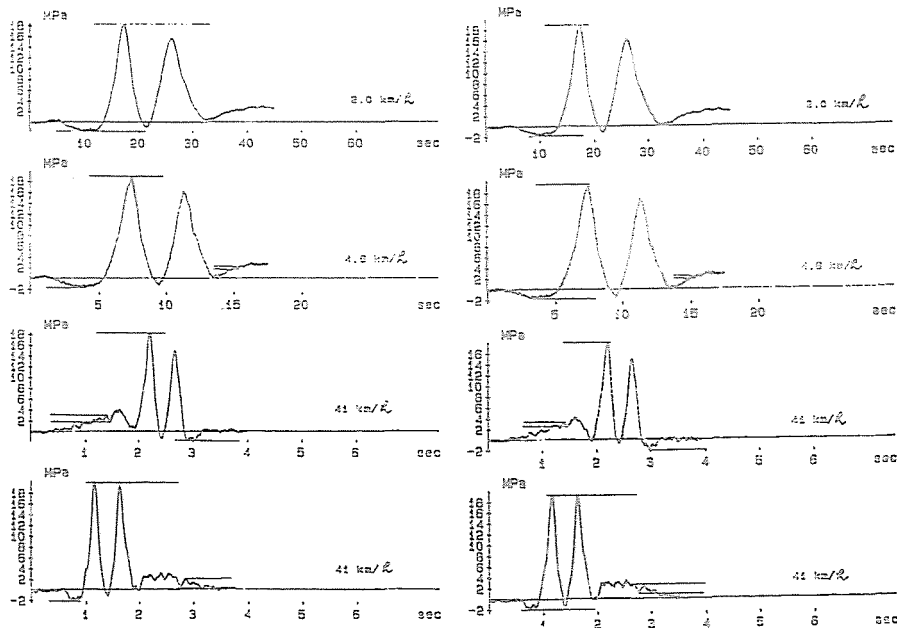
Fig. 13.

VG.13 Stringer gauge N<sup>2</sup>3 Load: A 124VG.14 Stringer gauge N<sup>2</sup>4 Load: A 124.

Number of gauge 3				Type of load A 124 (VQ.13)		
	Stresses		MPa	Dynamic load		
	maximum	minimum	delta	max/statmax	min/statmin	delta/absmax
Stat	18.1	-0.9	—	—	—	—
Din1	18.6	-1.8	0.5	1.03	—	1.01
Din2	18.1	-1.8	1.3	—	—	1.04
Din3	19.8	-2.2	1.4	1.09	—	1.04

Number gauge 4				Type of load: A 124 (VQ.14)		
	Stresses		MPa	Dynamic factor		
	maximum	minimum	delta	max/statmax	min/statmin	delta/absmax
Stat	18.6	-1.1	—	—	—	—
Din1	19.2	-1.5	0.9	1.03	—	1.01
Din2	18	-1.9	0.9	—	—	1.02
Din3	19.3	-1.9	1.7	1.04	—	1.04
